**REPORT ON FULL SCALE LABORATORY TESTS ON
TRIPSTOPTM PVC JOINERS FOR RESIDENTIAL PAVEMENT
(FOOTPATH / SIDEWALK) OF 100 mm THICKNESS**

Y.M. Xie, S. Setunge and Y.C. Koay
School of Civil and Chemical Engineering
RMIT University, Melbourne, Australia

Research Report No.: **RMIT/TS/6**

22 March 2006

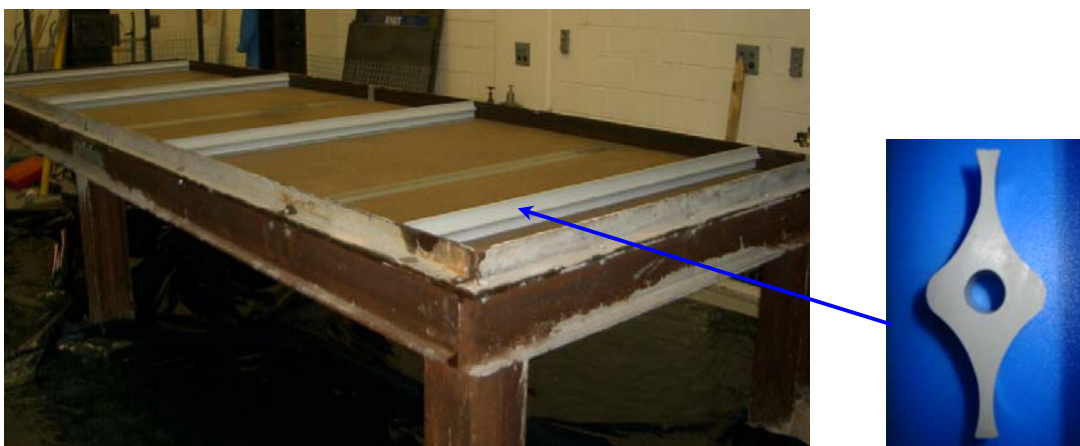
Figure 1. The locations and the cross-sectional shape of TripStop™ PVC joiners

Four TripStop™ PVC joiners were installed in the prototype residential pavement (footpath / sidewalk). They were 1.5m apart from each other. The two ends of the pavement were restrained by steel angles. The locations of the PVC joiners and their cross-sectional shape are shown in Figure 1.

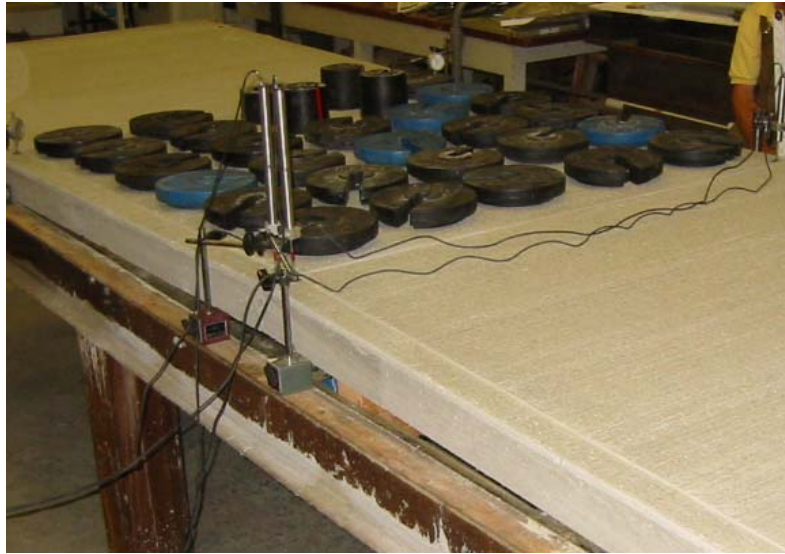
Figure 5. 300 kg dead load added on the Slab 2

From Figure 4, it is seen the stepping displacement increased when additional dead load was added to the slab. The maximum stepping displacement recorded without additional load on slab was 1.05 mm, which happened when the corresponding stepping displacement on the other side of the slab was 1.32 mm. This indicates that the slabs were slightly tilted. It could be because the jacking force was not exactly at the centre or the slabs / joiners were not perfectly symmetrical. The self-weight of each slab was about 540 kg. The maximum stepping displacement recorded in the test was 2.11 mm when 300 kg of dead load was put on Slab 2, as shown in Figure 5.

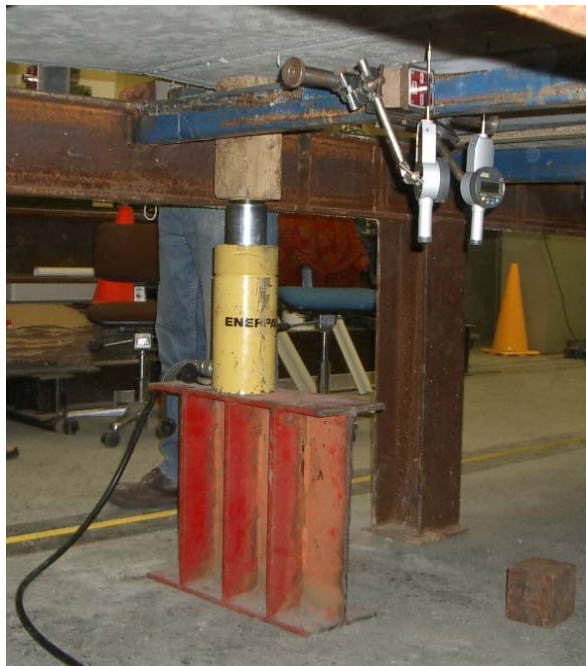
Figure 6. Slab 1 being pushed up at a corner

With the previous tests, the slabs were moved up almost uniformly across the width, resulting in a uniform distribution of force on the TripStop™ PVC joiner. A more challenging case would be the one where Slab 1 is pushed up at a corner as shown in Figure 6.

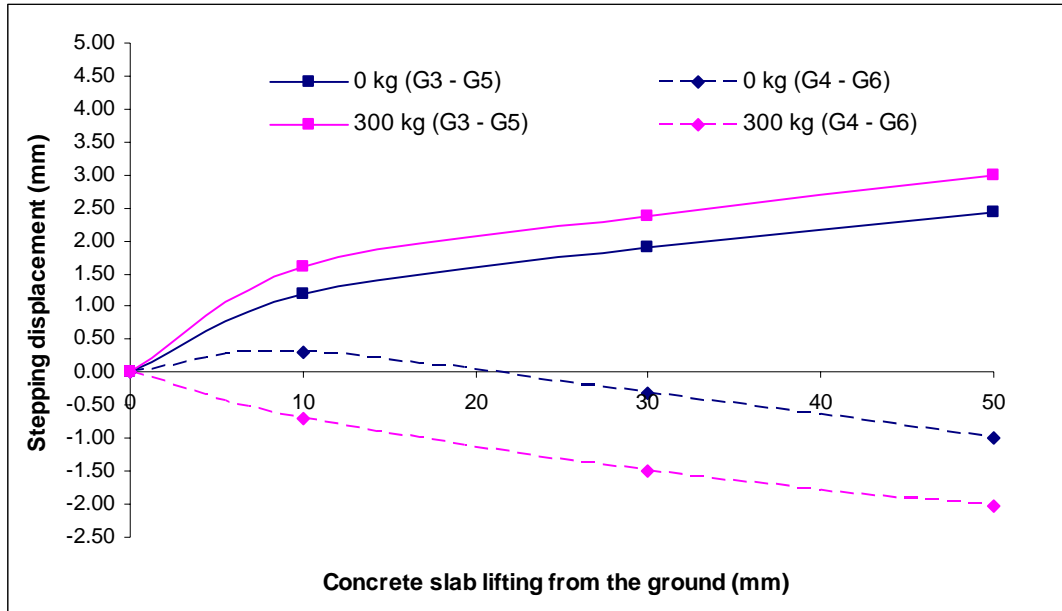
Figure 8. Stepping displacement - Slab 1 was jacked up at point C with no additional and the 300 kg of concentrated load was applied to point D in Slab 2.

It is seen that the stepping displacement with no additional load near G3 (where the jacking force was applied) was 2.44 mm. On the other side of the slab, the stepping displacement was - 0.99 mm. This indicates that the slabs were slightly tilted due to Slab 1 being pushed up at a corner.

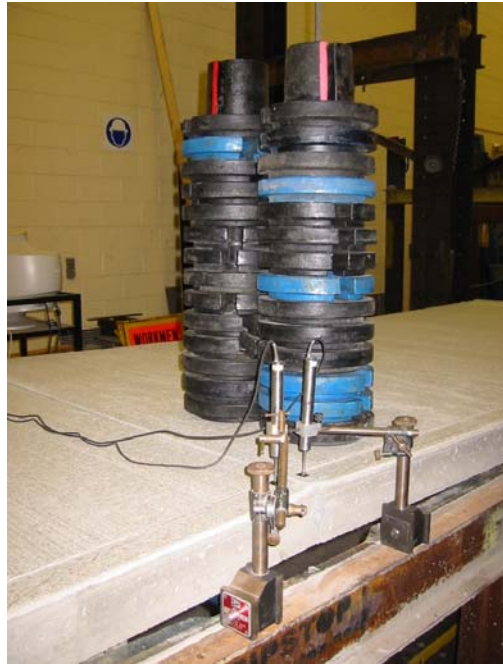
Figure 9. Slab 1 being jacked up at a corner with 300 kg concentrated load applied to adjoining slab

The last test on Joint 2 was the most challenging one where a 300 kg concentrated load was applied. Figure 9 shows such a set-up. The hydraulic jack pushed up Slab 1 at point C and the 300 kg concentrated load was applied to point D in Slab 2 (refer to Figure 7). To assess the performance of TripStop™, the ‘worst scenario’ load case was where one slab was pushed up at a corner while a concentrated load was applied next to it on the adjoining slab. The maximum stepping displacement at G6 was 2.98 mm, while on the other side of the slab the stepping displacement was -2.01 mm.

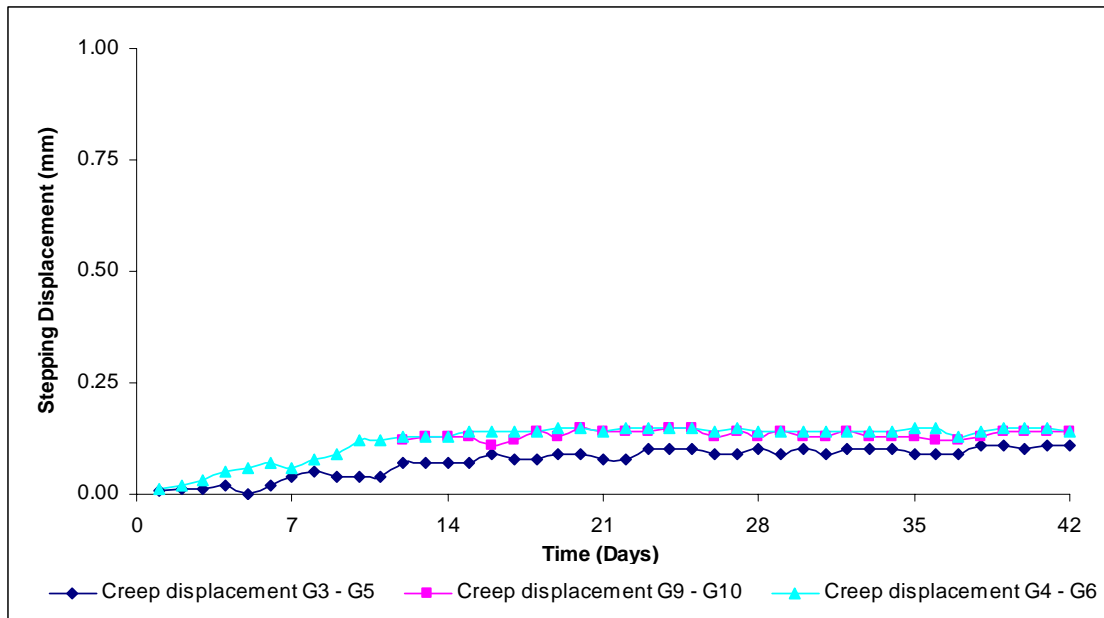
Figure 11 Stepping displacement due to creep

The creep displacement results were recorded over a period of 6 weeks from 23 December 2005 to 2 February 2006 and the details are given in Appendix 1. Figure 11 shows the additional stepping displacement due to creep. The maximum creep displacement measured over the period of 6 weeks was 0.15 mm, which is negligible.

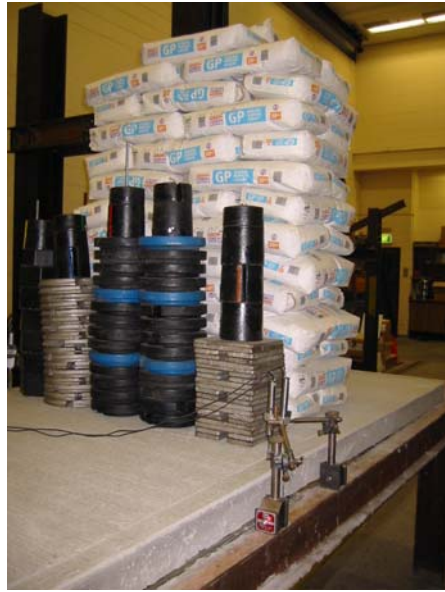
Figure 15. Slab 2 being jacked up at line EF with 2,000kg load added on Slab 3

After all the tests were carried out, overloading test was conducted. The plan of concrete testing frame is shown in Figure 10. Slab 2 was jacked up at line EF and a massive 2,000 kg load was added on Slab 3 as shown in Figure 15. This was to confirm the PVC joiner had more than enough capacity to resist vertical shear force and control differential vertical movement, thus reducing the potential for serviceability problems and stepping displacement.
